Manhole Inspection Summary

Manhole # S37Y1_009MH

Location Address: **3801 S Hanover St** Cross Street: **Washburn Ave.**

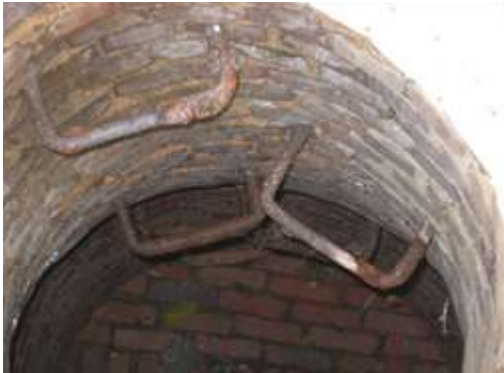
Steps Count: **7** Missing: **0** ☒ **Corroded**

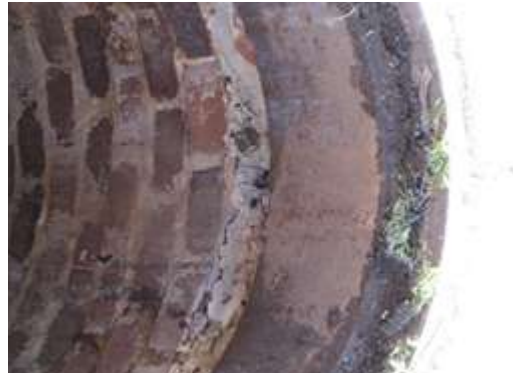
Defect 1

Chimney / Frame Adjustment ☒ Exists Material: **Brick** ☐ Parged Height: **30** (in.)
Condition: ☐ Sound ☐ Cracked ☐ Root Intrusion ☒ **Loose Brick** ☐ Deteriorated
Infiltration: ☒ None ☐ Joint ☐ Cracks ☐ Mortar ☐ Roots ☐ Wall

Loose bricks in chimney

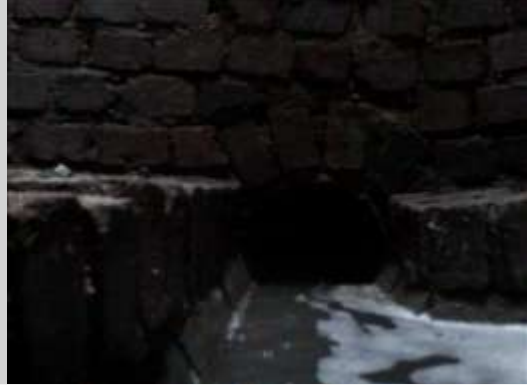
12 O'Clock Outflow

Pipe Height: **8.4** (in.) Rod and Bar (Angled)
Pipe Material: **Clay** ☐ Pipe Lined
Invert Depth: **10.66** (ft.) Flow Characteristics: **Slow**
Deposits: ☒ None ☐ Mud ☐ Sludge ☐ Debris ☐ Grease
Silt Depth: (in.) Deposits Extent:
Infiltration: **None** Pipe Seal Cond: **Sound**

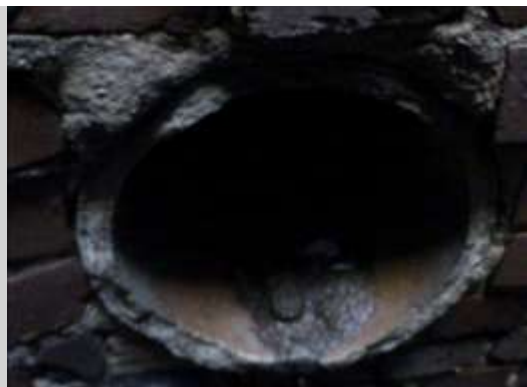
3 O'Clock Inflow

Pipe Height: **8.4** (in.) Rod and Bar (Angled)
Pipe Material: **Clay** ☐ Pipe Lined
Invert Depth: **7.36** (ft.) Flow Characteristics: **None**
Deposits: ☒ None ☐ Mud ☐ Sludge ☐ Debris ☐ Grease
Silt Depth: (in.) Deposits Extent:
Infiltration: **None** Pipe Seal Cond: **Sound**

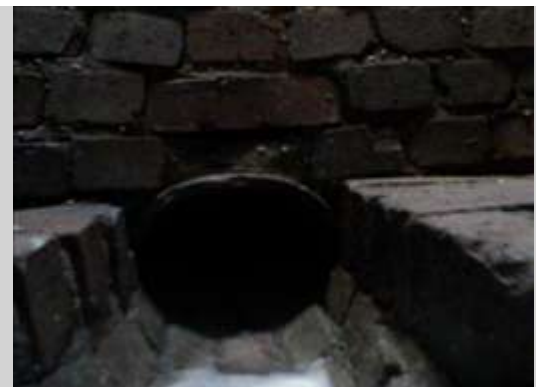
Pipe In @ 3 O'Clock

Drop: **Outside** Rod and Bar
Angled: **Yes** Reading: **9.36** (ft.)
Inv Depth: **10.36** (ft.)
Drop Condition: **Open**

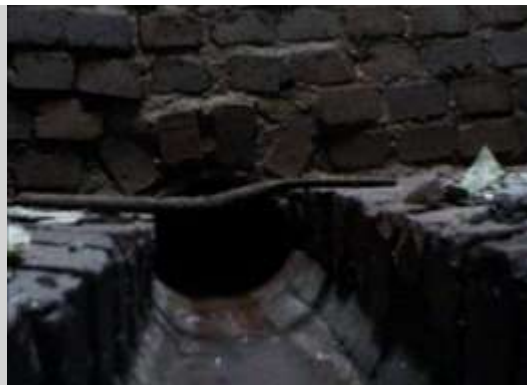
6 O'Clock Inflow

Pipe Height: **6** (in.) Rod and Bar (Angled)

Invert Depth: **10.46** (ft.) Flow Characteristics: **Fast**

Infiltration: **None** Pipe Seal Cond: **Sound**
